# Laser Diode Power Supply Transient Response Under Typical Laser Diode Fault Conditions

Vektrex April, 2007

**Abstract – This paper discusses typical multi-laser drive topologies used in burn-in or life testing applications and presents possible laser failure mechanisms that can challenge power supplies driving the lasers. A typical laser failure scenario is then proposed – a gradual increase in laser impedance followed by a sudden drop in impedance. A test circuit consisting of six lasers and a MOSFET transistor is constructed and this circuit is used to test how three laser diode power supplies respond in this scenario. Observed voltage and current spikes produced by the supplies are presented and the excess power and energy delivered to the lasers is calculated.**

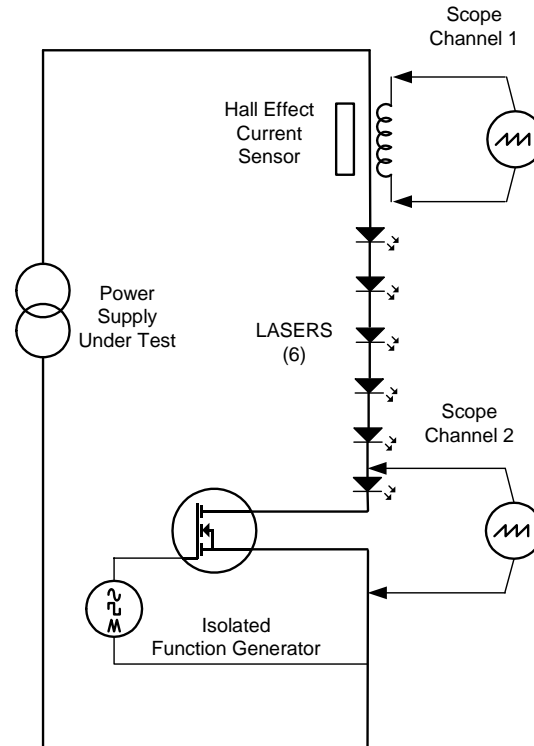
Figure 1 - Experimental Setup

In this setup the power supply under test was arranged to drive six CCP-type lasers; the lasers were mounted on a water-cooled plate and the laser outputs were directed to a water-cooled beam dump. The circuit included a 200:1 hall-effect AC/DC current sensor to measure the current through the lasers and an 10:1 isolated oscilloscope probe to measure the voltage across the MOSFET/laser pair. The MOSFET was driven with an inverted saw tooth waveform as shown in Figure 2.

To simulate a failing laser's gradual increase in impedance followed by a sudden drop, the setup in Figure 1 was used.

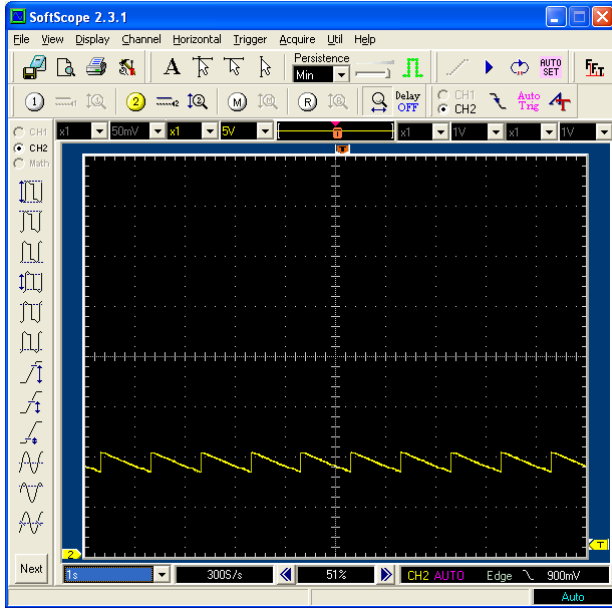
**Figure 2 - MOSFET Drive Waveform**

**Ch 2 - 5V/div, 1S/div**

By adjusting the frequency and lower end point of this waveform the MOSFET was driven from saturation, to the linear region and then rapidly back into saturation. For this testing a frequency of roughly 2Hz and a lower voltage of roughly 3.2V was used.

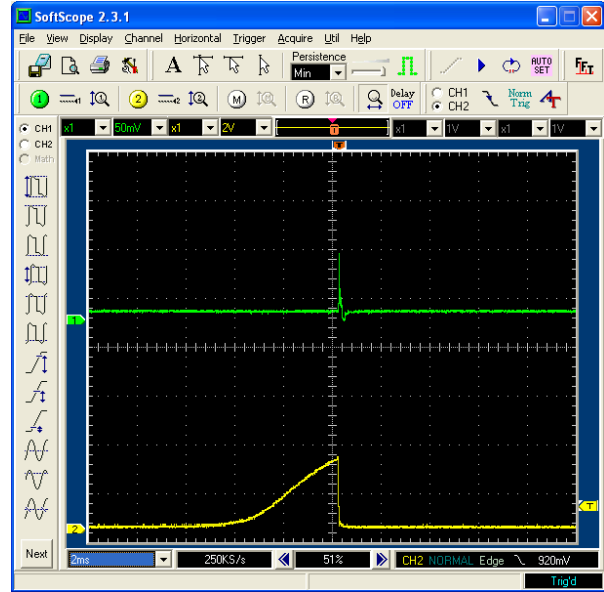
**Figure 3 – MOSFET/Laser Current & Voltage**

This action resulted in an increasing ramp voltage waveform across the last laser as shown in Figure 3. The amplitude of this rising voltage varied from a few volts for the SpikeSafe current source<sup>1</sup> to 20-60 volts for one of the tested supplies. The increasing ramp terminated in a sharp drop. This drop induced a current spike through the laser string as shown in the top trace of Figure 3.

**Ch 1 – 10A/div, Ch 2 - 20V/div, 1S/div**

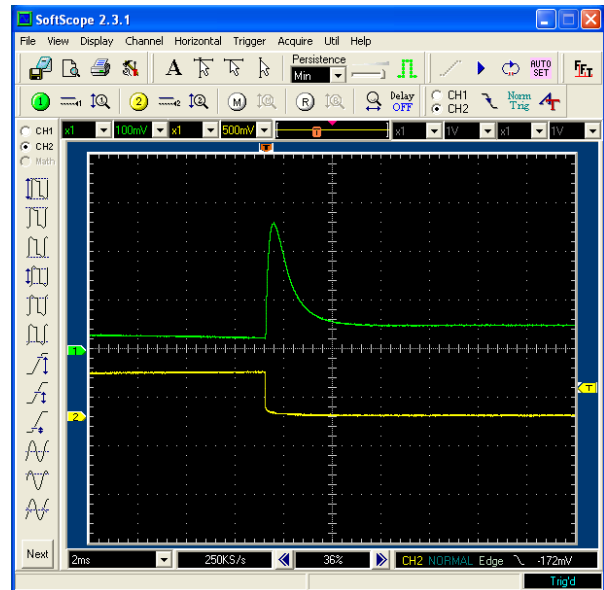
**Figure 4 – Supply 1 High/Low 10A**

Supply 1 was tested using the experimental setup at 10A and 20A. The supply's voltage setting was adjusted to a few volts above the nominal to limit the rise in compliance voltage; and for two of the tests, over voltage protection was enabled. The 10A result without over voltage protection is shown in Figure 4. Trace 2 shows that prior to the sudden decrease in impedance, the forward voltage across the MOSFET/laser pair had risen to roughly 4.5V. This was high enough to drive the supply into constant voltage mode, reducing the current delivered to roughly 4A. When the transition to low impedance occurred, the current spiked up to 52A, and then recovered to the 10A set point in 3mS.

**Ch 1 – 20A/div, Ch 2 – 5V/div, 2mS/div<sup>2</sup>**

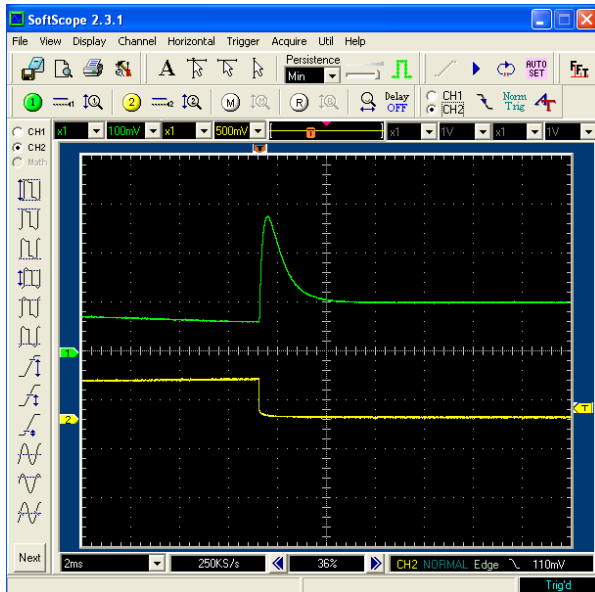
**Figure 5 – Supply 1 High/Low 20A**

In Figure 5 the 20A result is shown. The 20A result was very similar to the 10A test, with the current spiking to 56A before recovering to the set point. Figure 6 and Figure 7 show 20A tests with the Supply 1's over voltage protection set to prevent a large buildup of forward voltage. With over voltage protection enabled, the supply shut off before the transition to low impedance could occur.

**Ch 1 – 20A/div, Ch 2 – 5V/div, 2mS/div**

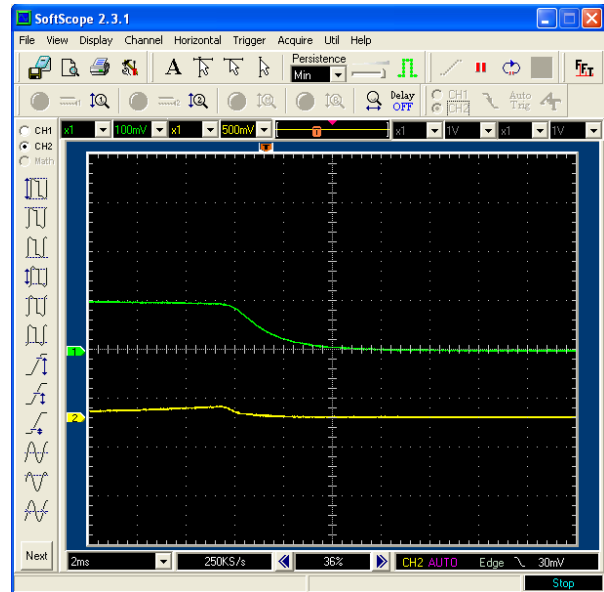
**Figure 7 - Supply 1 High/Low 20A, 7.9V OVP**

**Ch 1 – 20A/div, Ch 2 – 5V/div, 2mS/div**

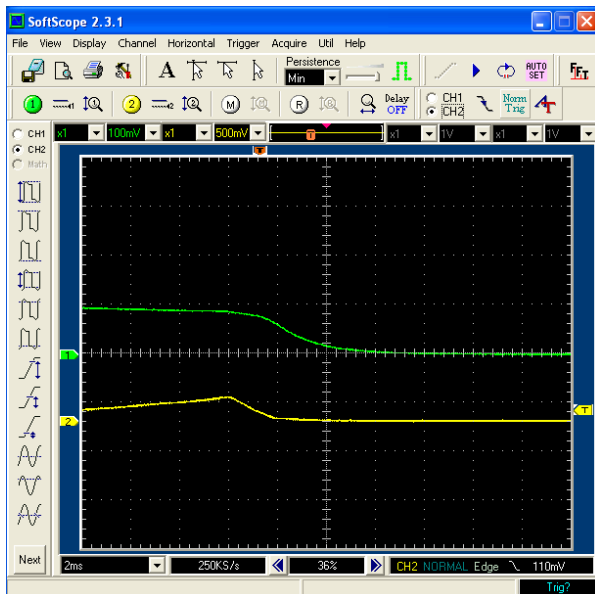
**Figure 6 - Supply 1 High/Low 20A, 9V OVP**

**Ch 1 – 20A/div, Ch 2 – 5V/div, 2mS/div**

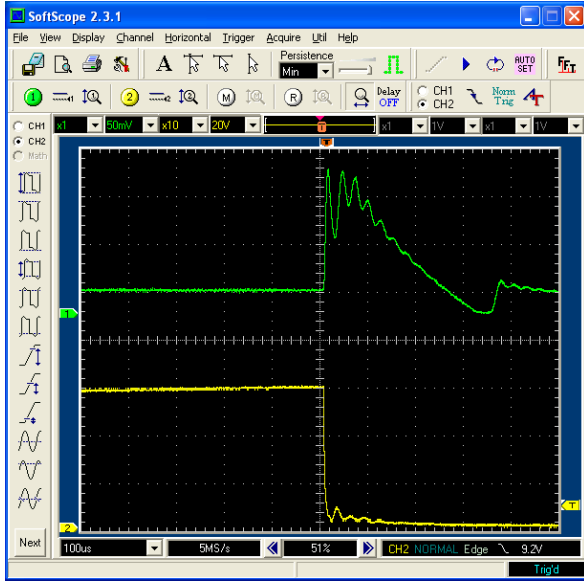
**Figure 8 – Supply 2 High/Low 5A**  
 Ch 1 – 10A/div, Ch 2 – 20V/div, 100uS/div

Supply 2 did not have a constant voltage mode or over voltage protection. Without the voltage limiting provided by these features, the supply increased its output voltage to the full compliance voltage during the high impedance phase of the test. Unlike the 4.5V rise of the Supply 1, this was a 45-60V rise across the MOSFET/laser pair. Then, when the transition to low impedance occurred, the current spiked upward of 20-30A above the setpoint, recovering in roughly 300-400uS. The relative amplitude of the spike was worst at 5A and fairly constant at 24A above setpoint for currents from 10A to 40A. See Figure 8 - Figure 11.

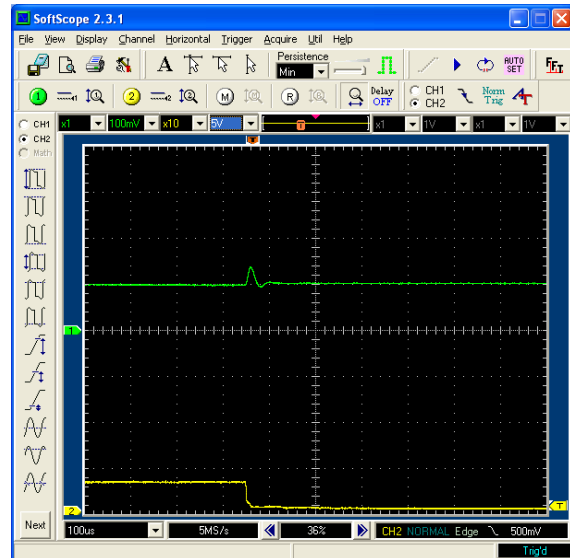
Figure 13 - SpikeSafe High/Low 20A

The SpikeSafe 200 was tested at 10A and 20A. For this testing dV/dt detection was disabled, as it would have shut off the output before the low impedance portion of the test. Initially the same MOSFET drive conditions were used as those used for Supply 2, however it was found that that even with dV/dt detection disabled, the SpikeSafe unit would shut down with an over voltage fault under these conditions. To overcome this, the MOSFET drive waveform was adjusted to reduce the rise in forward voltage to roughly 3V above nominal. Under these conditions current remained on during the low impedance portion of the test. With the new setting, the SpikeSafe produced a current spike 4-8A above the setpoint with duration of roughly 20uS. See Figure 12 - Figure 13. After testing at 10A and 20A, the SpikeSafe's over current setting was adjusted to its most sensitive setting, and the 20A test was repeated. With the lower trip point, the power supply shut off when the MOSFET transitioned to low impedance. See Figure 14.

Ch 1 – 20A/div, Ch 2 – 5V/div, 100uS/div

The Vektrex and Supply 1 units did not allow the voltage to rise more than a few volts above the nominal value, and so they had much lower power dissipation during this phase of the fault. For the Vektrex supply:

$$20A \times 3V = 60W$$

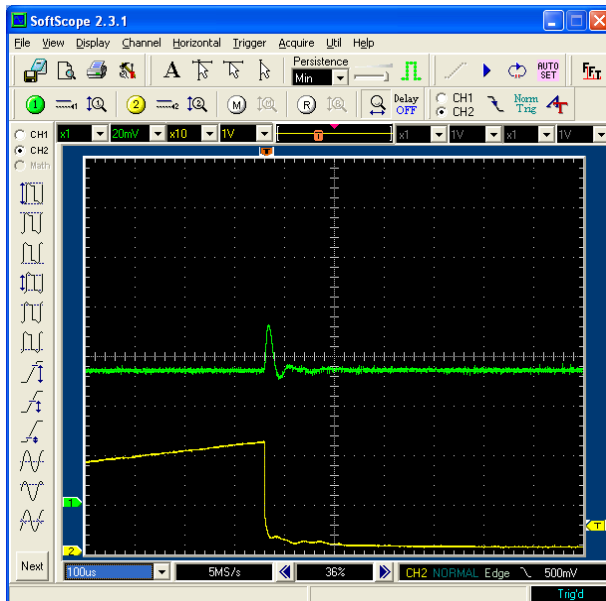
Figure 12 - SpikeSafe High/Low 10A

Ch 1 – 4A/div, Ch 2 – 1V/div, 100uS/div

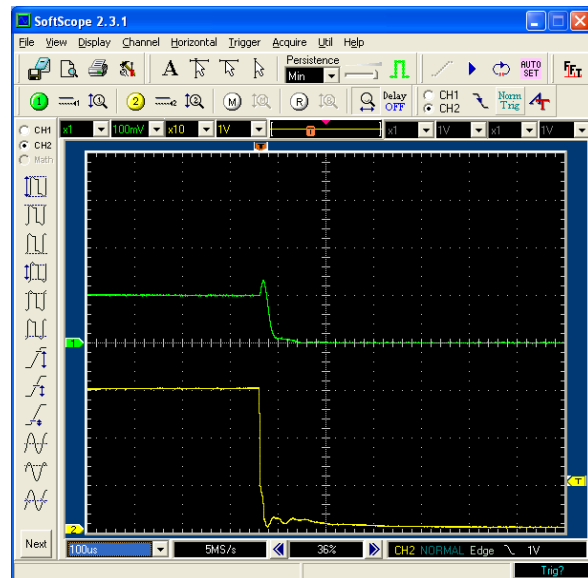
Figure 14 - SpikeSafe High/Low 20A With Over Current Trip

Ch 1 – 20A/div, Ch 2 – 1V/div, 100uS/div
