Laser Diode Power Supply Transient Response Under Typical Laser Diode Fault Conditions

Vektrex April, 2007

Abstract – This paper discusses typical multi-laser drive topologies used in burn-in or life testing applications and presents possible laser failure mechanisms that can challenge power supplies driving the lasers. A typical laser failure scenario is then proposed – a gradual increase in laser impedance followed by a sudden drop in impedance. A test circuit consisting of six lasers and a MOSFET transistor is constructed and this circuit is used to test how three laser diode power supplies respond in this scenario. Observed voltage and current spikes produced by the supplies are presented and the excess power and energy delivered to the lasers is calculated.

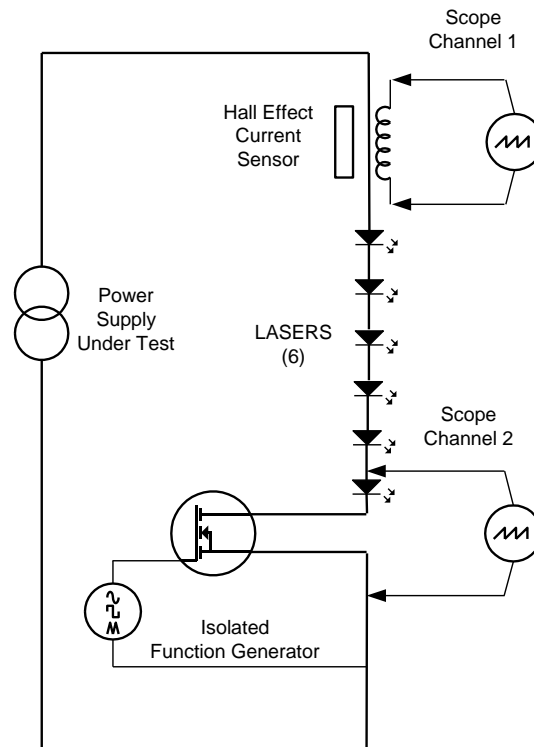
Figure 1 - Experimental Setup

To simulate a failing laser’s gradual increase in impedance followed by a sudden drop, the setup in Figure 1 was used.

In this setup the power supply under test was arranged to drive six CCP-type lasers; the lasers were mounted on a water-cooled plate and the laser outputs were directed to a water-cooled beam dump. The circuit included a 200:1 hall-effect AC/DC current sensor to measure the current through the lasers and an 10:1 isolated oscilloscope probe to measure the voltage across the MOSFET/laser pair. The MOSFET was driven with an inverted saw tooth waveform as shown in Figure 2.

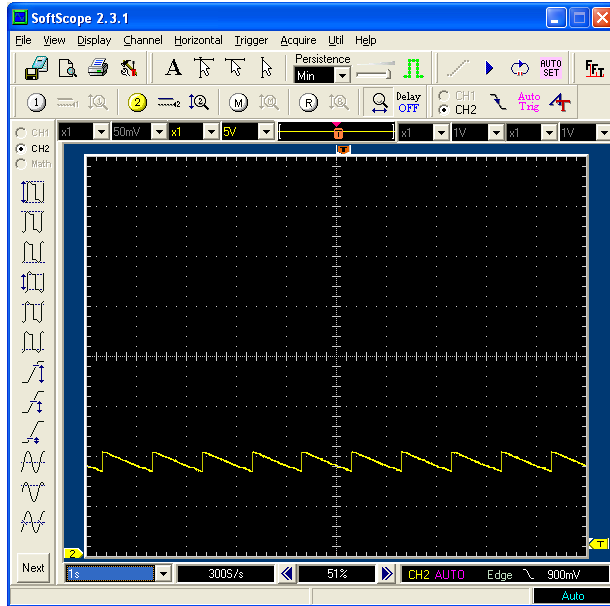
Figure 2 - MOSFET Drive Waveform

Ch 2 - 5V/div, 1S/div

By adjusting the frequency and lower end point of this waveform the MOSFET was driven from saturation, to the linear region and then rapidly back into saturation. For this testing a frequency of roughly 2Hz and a lower voltage of roughly 3.2V was used.

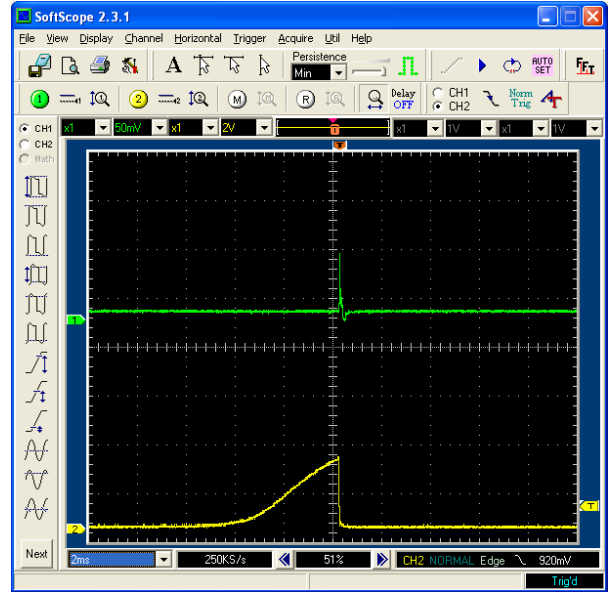
Figure 3 – MOSFET/Laser Current & Voltage

This action resulted in an increasing ramp voltage waveform across the last laser as shown in Figure 3. The amplitude of this rising voltage varied from a few volts for the SpikeSafe current source¹ to 20-60 volts for one of the tested supplies. The increasing ramp terminated in a sharp drop. This drop induced a current spike through the laser string as shown in the top trace of Figure 3.

Ch 1 – 10A/div, Ch2 - 20V/div, 1S/div

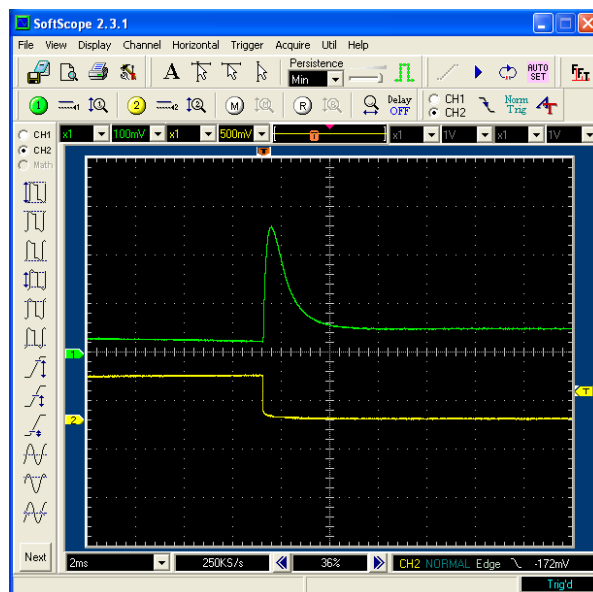
Figure 4 – Supply 1 High/Low 10A
Ch 1 – 20A/div, Ch 2 – 5V/div, 2mS/div²

Supply 1 was tested using the experimental setup at 10A and 20A. The supply's voltage setting was adjusted to a few volts above the nominal to limit the rise in compliance voltage; and for two of the tests, over voltage protection was enabled. The 10A result without over voltage protection is shown in Figure 4. Trace 2 shows that prior to the sudden decrease in impedance, the forward voltage across the MOSFET/laser pair had risen to roughly 4.5V. This was high enough to drive the supply into constant voltage mode, reducing the current delivered to roughly 4A. When the transition to low impedance occurred, the current spiked up to 52A, and then recovered to the 10A set point in 3mS.

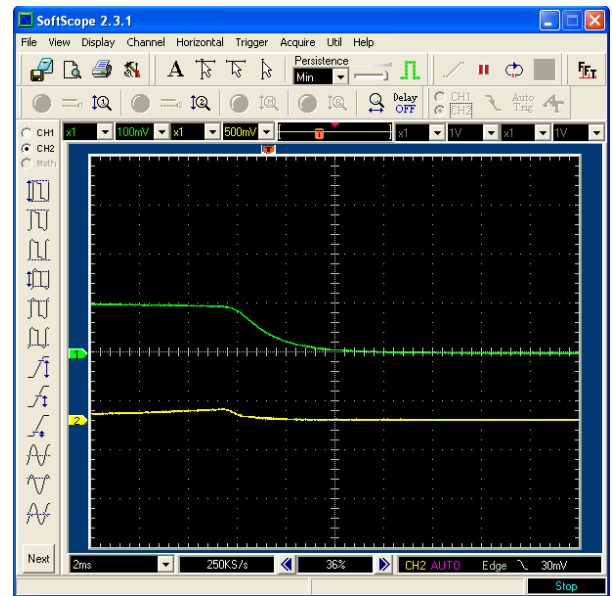
Figure 7 - Supply 1 High/Low 20A, 7.9V OVP
Ch 1 – 20A/div, Ch 2 – 5V/div, 2mS/div

In Figure 5 the 20A result is shown. The 20A result was very similar to the 10A test, with the current spiking to 56A before recovering to the set point. Figure 6 and Figure 7 show 20A tests with the Supply 1's over voltage protection set to prevent a large buildup of forward voltage. With over voltage protection enabled, the supply shut off before the transition to low impedance could occur.

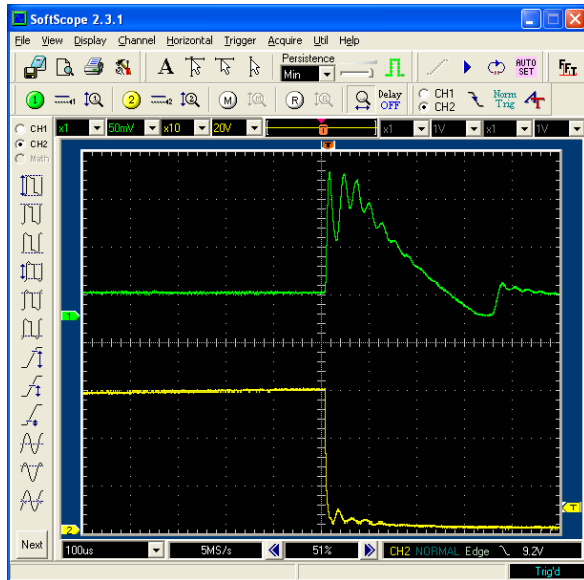
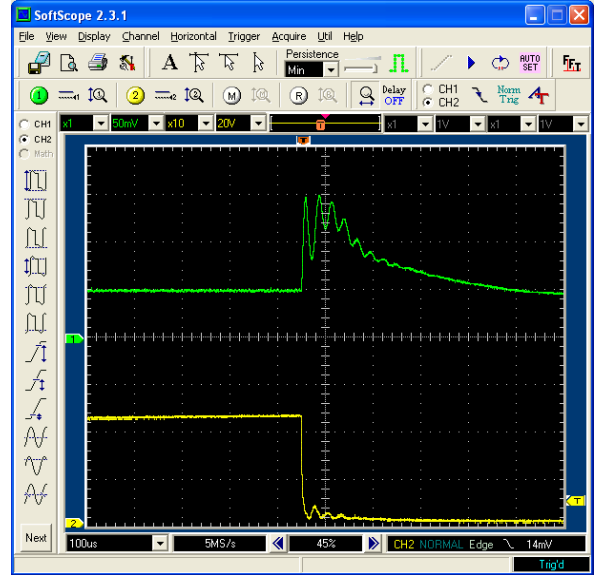
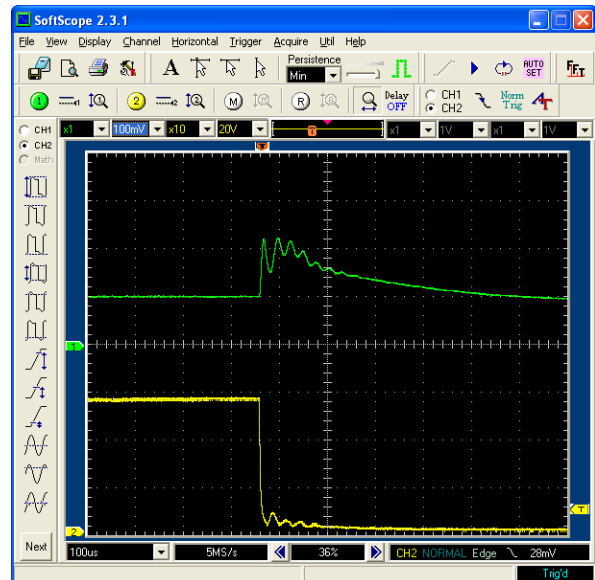
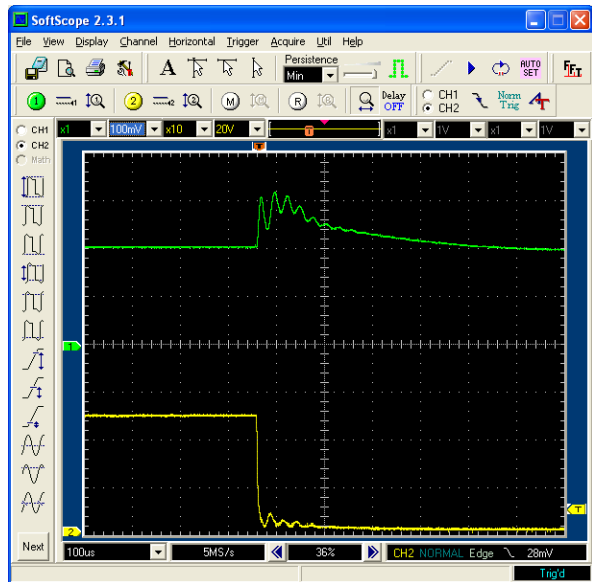
Supply 2 did not have a constant voltage mode or over voltage protection. Without the voltage limiting provided by these features, the supply increased its output voltage to the full compliance voltage during the high impedance phase of the test. Unlike the 4.5V rise of the Supply 1, this was a 45-60V rise across the MOSFET/laser pair. Then, when the transition to low impedance occurred, the current spiked upward of 20-30A above the setpoint, recovering in roughly 300-400uS. The relative amplitude of the spike was worst at 5A and fairly constant at 24A above setpoint for currents from 10A to 40A. See Figure 8 - Figure 11.

Figure 8 – Supply 2 High/Low 5A
Ch 1 – 10A/div, Ch 2 – 20V/div, 100uS/div

Figure 9 – Supply 2 High/Low 10A
Ch 1 – 10A/div, Ch 2 – 20V/div, 100uS/div

Figure 10 – Supply 2 High/Low 20A
Ch 1 – 20A/div, Ch 2 – 20V/div, 100uS/div

Figure 11 – Supply 2 High/Low 40A
 Ch 1 – 20A/div, Ch 2 – 20V/div, 100uS/div

Supply 2 produced a significant excess voltage as the supply often rose close to the full 60V+ compliance during the high impedance portion of the fault. For the 20A test case, the peak power dissipation was:

$$20A \times 56V = 1120W$$

Since the nominal power is 20W, this was 1100W above normal. This rise to 56V took roughly 1.5S so the excess energy delivered was:

$$1100W \times 1.5S \times 0.5 = 825J$$

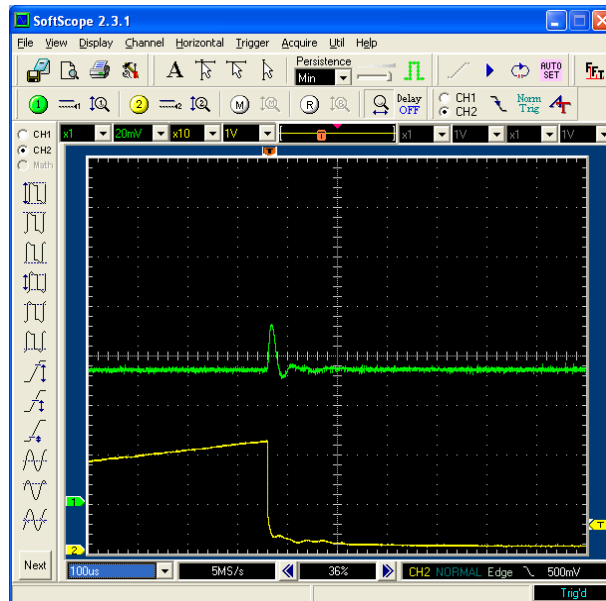
Figure 12 - SpikeSafe High/Low 10A
 Ch 1 – 4A/div, Ch 2 – 1V/div, 100uS/div

The SpikeSafe 200 was tested at 10A and 20A. For this testing dV/dt detection was disabled, as it would have shut off the output before the low impedance portion of the test. Initially the same MOSFET drive conditions were used as those used for Supply 2, however it was found that that even with dV/dt detection disabled, the SpikeSafe unit would shut down with an over voltage fault under these conditions. To overcome this, the MOSFET drive waveform was adjusted to reduce the rise in forward voltage to roughly 3V above nominal. Under these conditions current remained on during the low impedance portion of the test. With the new setting, the SpikeSafe produced a current spike 4-8A above the setpoint with duration of roughly 20uS. See Figure 12 - Figure 13. After testing at 10A and 20A, the SpikeSafe’s over current setting was adjusted to its most sensitive setting, and the 20A test was repeated. With the lower trip point, the power supply shut off when the MOSFET transitioned to low impedance. See Figure 14.
